**NUMBER:** 18-003-04

Flash: Poor A/C Performance, Slow Fuel Gauge Response, and Diagnostic Trouble Codes (DTC's) P0341 **\*\*and P1757\*\***

2003 - **\*\*2004\*\*** (DR) Ram Truck

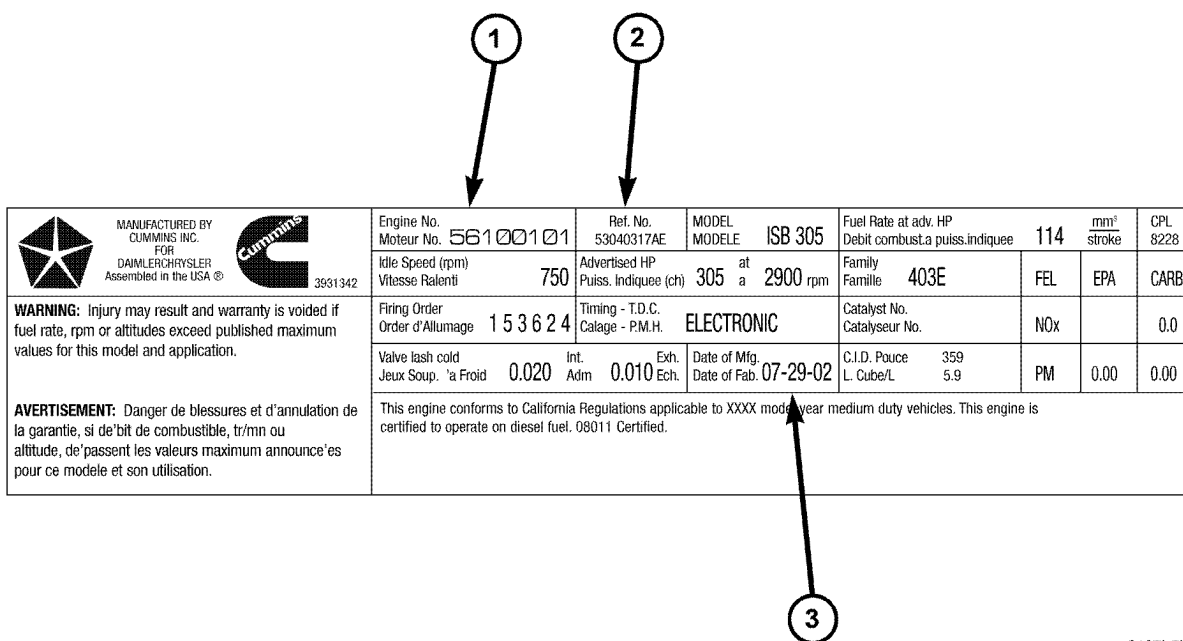
**FIGURE 1 - ENGINE DATA PLATE (2003 AND LATER SHOWN)**

**NOTE:** This bulletin applies to DR vehicles equipped with a Cummins Turbo Diesel engine (sales code ETC or ETH), with an engine serial number **\*\*57130284\*\*** or earlier (Figure 1); and the engine date of manufacture on or before **\*\*December 10, 2003\*\***.

- c. For 2003 and later, if the old part number is not known, highlight the proper calibration based on the Reference No. located in the "Ref. No." box, at the top, center of the Engine Data Plate (Figure 1).
