Distributor/Dealer Service Instructions for:

Customer Satisfaction Notification No. C30 PCM Electrical Connector Seals

Subject

The Powertrain Control Module (PCM) electrical connector seal (one or all) on about 63,000 of the above vehicles (1531 in Int'l markets) may be out of place or "rolled". This could allow water to enter into the PCM. Water and the resulting corrosion inside of the connector can cause various electrical and driveability concerns.

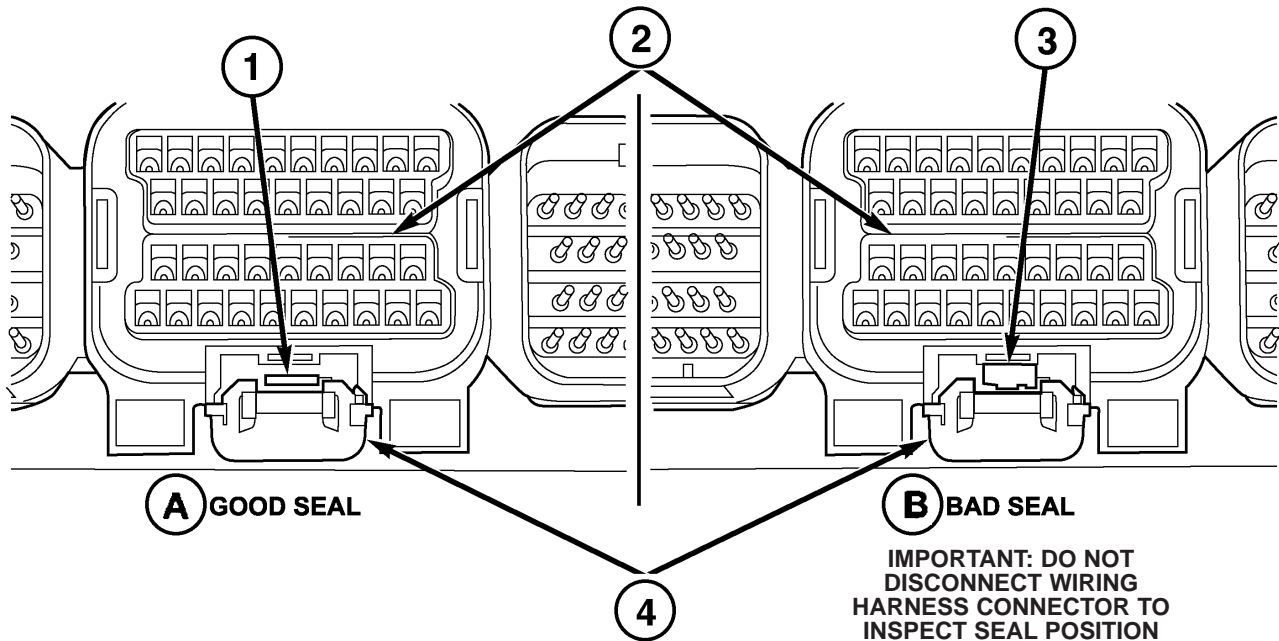
FIGURE 2

NOTE: If an ORANGE colored seal is visible through the red locking tab, no further action is necessary. Only light blue seals require repair.

A-	GOOD SEAL
B-	BAD SEAL
1-	SEAL IS BARELY VISIBLE - GOOD SEAL - NO ACTION NECESSARY
2-	NGC3 WIRING HARNESS CONNECTOR (WIRES REMOVED FOR VISUAL CLARITY)
3-	LIGHT BLUE SEAL VISIBLE - SEAL IS OUT OF PLACE
4-	CONNECTOR LOCK TAB

7. Disconnect each PCM electrical connector that has the **light blue seal** visibly out of place (Figure 2).

8. Inspect the disconnected electrical connector(s) and mating PCM connector for the presence of water and/or corrosion.

- **If any corrosion is present in the harness and/or PCM connector, the PCM and affected wiring harness must be replaced. Continue with Section B – Replace PCM.**
- **If water or moisture is present, without any signs of corrosion, dry the connector as follows:**
 - a. Firmly tap the harness connector onto a paper towel to remove the majority of the water from the connector.
 - b. Using a blow dryer or heat gun, thoroughly dry out the harness and PCM connectors. Do NOT use shop air to blow out the connector.

- c. Continue with Step 9.
- **If NO water or corrosion is present in the harness and/or PCM connector,** continue with Step 9.
9. Carefully reconnect the PCM connector(s). This may take several attempts. Be sure to insert the connector straight into the module. If the connector is not inserted straight into the module, it may cause the seal to move out of place.

10. Verify that all seals are in place (Figure 2).
11. Reinstall the PCM. Tighten the PCM mounting bracket fasteners.
 - For CS/RS/JR vehicles, tighten the mounting bolts to 35 in–lbs (4 N·m).
