Distributor/Dealer Service Instructions for:

Customer Satisfaction Notification No. C30 PCM Electrical Connector Seals

Subject

The Powertrain Control Module (PCM) electrical connector seal (one or all) on about 63,000 of the above vehicles (1531 in Int'l markets) may be out of place or "rolled". This could allow water to enter into the PCM. Water and the resulting corrosion inside of the connector can cause various electrical and driveability concerns.

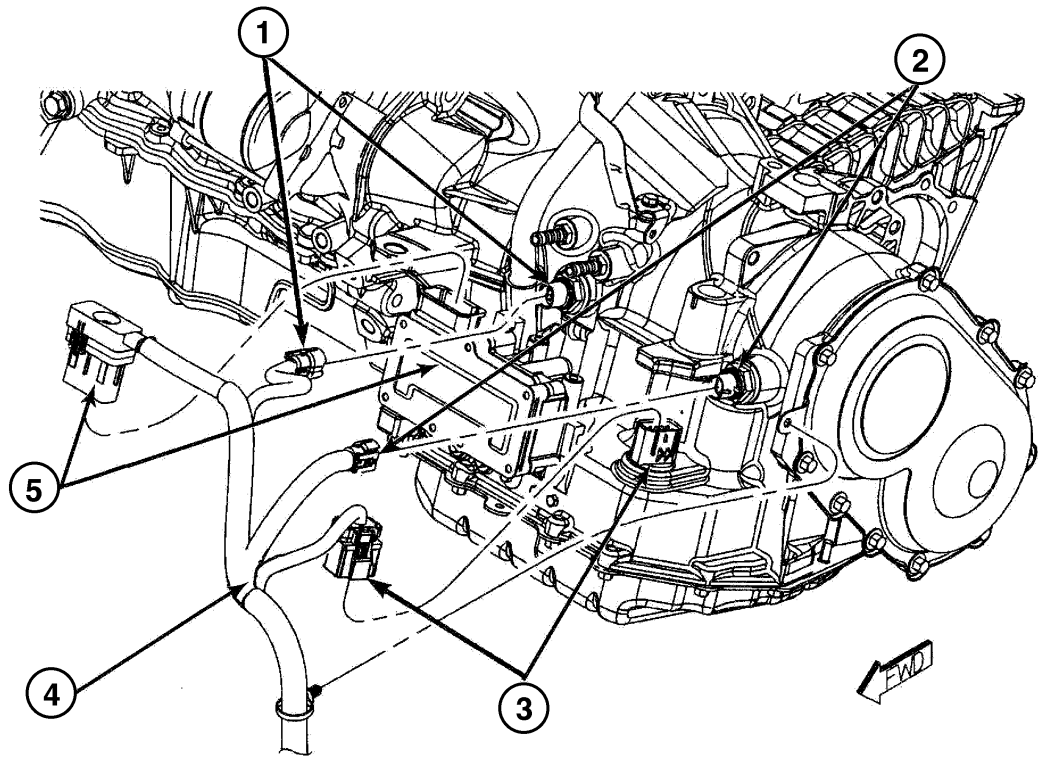
FIGURE 3

NOTE: Only those vehicles that have corrosion found during the inspection in Section A. require wiring harness replacement. Very few vehicles are expected to require wiring harness replacement.

1. Disconnect the grey 8-way connector at the left frame rail.
2. Lower the vehicle.
3. Disconnect the transaxle solenoid connector (Figure 3).

4. Disconnect the input and output speed sensor (Figure 3).
5. Disconnect the PRNDL switch connector (Figure 3).
6. Remove the harness from the vehicle.
7. Position the new harness onto the vehicle.

8. Connect the PRNDL switch connector (Figure 3).
9. Connect the input and output speed sensor (Figure 3).
10. Connect the transaxle solenoid connector (Figure 3).
